## **2016 Operations, Maintenance, and Monitoring Report**

### **GIWW - Perry Ridge West Bank Stabilization**

State Project Number CS-30  
Priority Project List 9

June 2016  
Calcasieu Parish

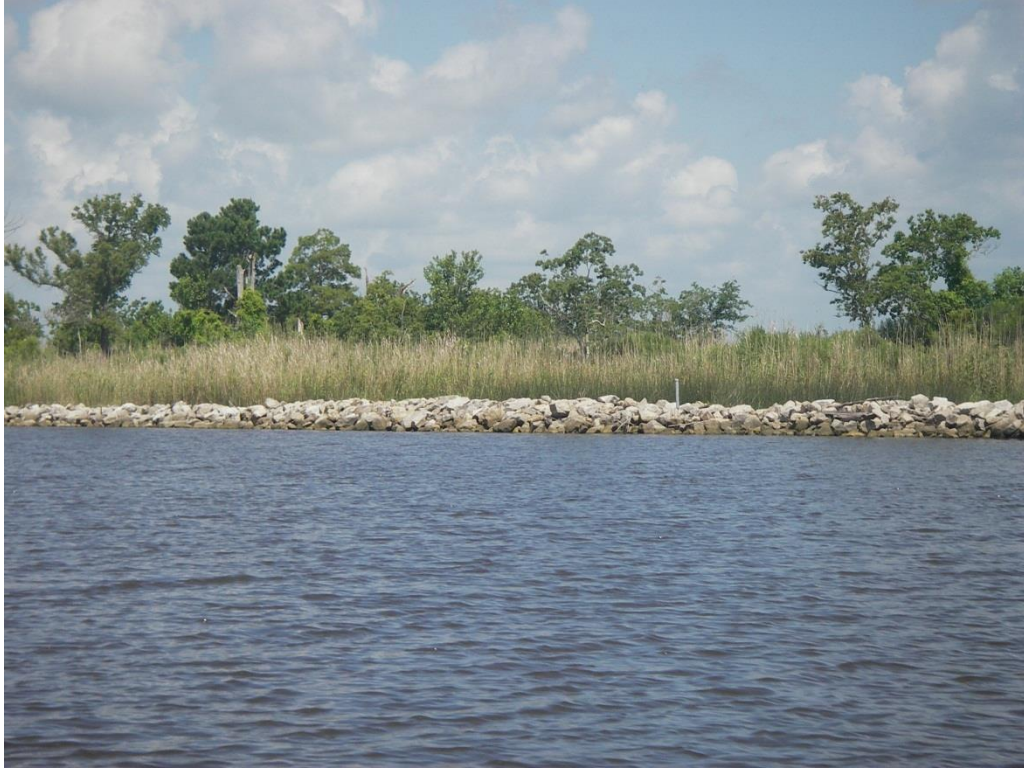
**Photo No. 1, Typical Rock Dike**

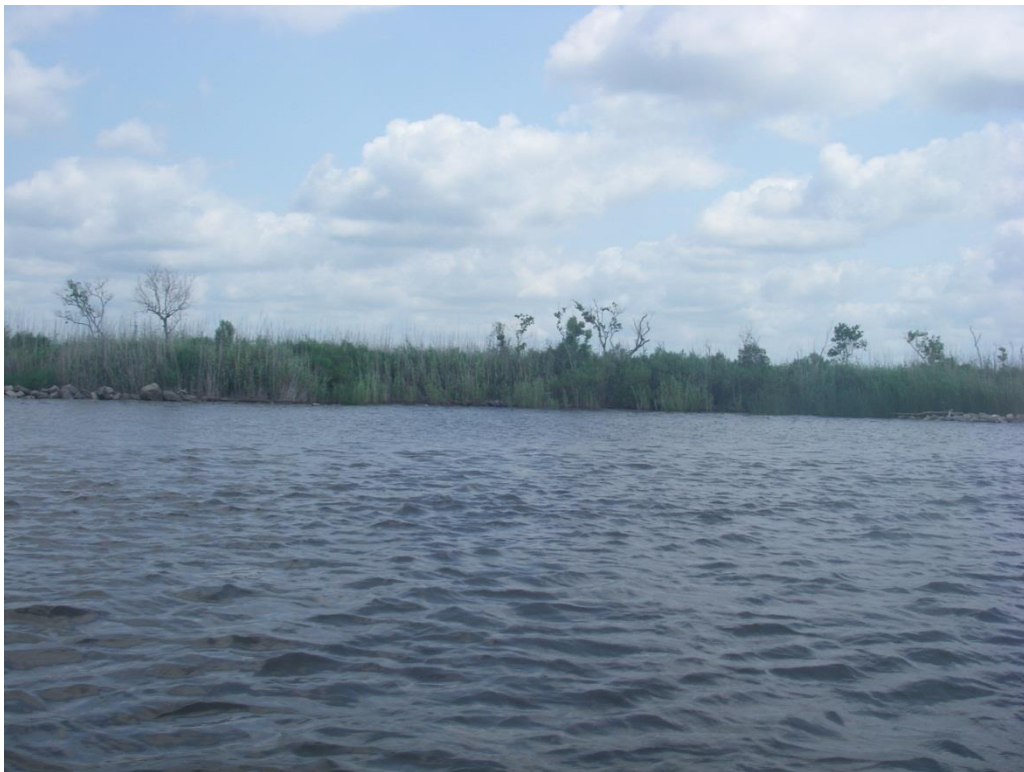
**Photo No. 2, Low Area of Displaced Rock Dike**

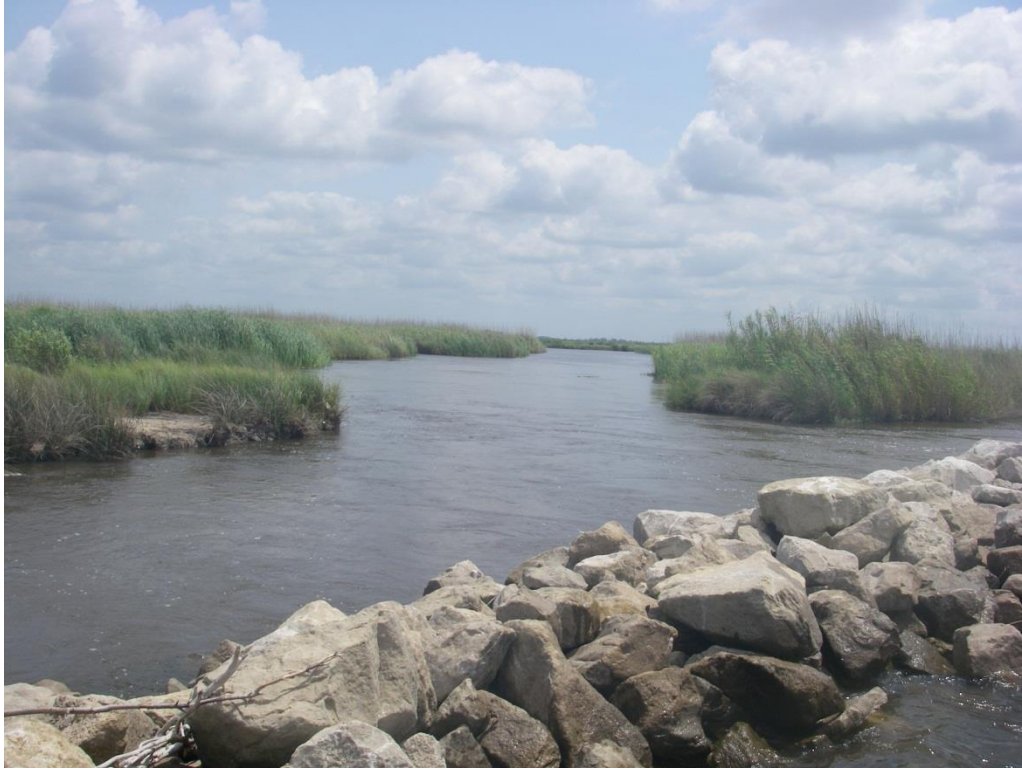
The 320ft breach in the earthen plug directly behind the rock dike mentioned in the inspection results is in need of repair. The earthen plug was original to the project and previously prevented higher salinity water in the GIWW from impacting the interior marsh.

**Photo No. 3,** Gap in Earthen Plug behind Rock Dike, Water Flow Channeling into Marsh

A maintenance event to address the breach in the earthen plug has been initiated by CPRA. Lonnie Harper & Associates Inc. has completed the surveying and engineering services necessary to prepare plans and specifications for the proposed breach repair. Incremental funding was approved at the October 10, 2013 CWPPRA Task Force Meeting. Once the permits are received, the maintenance event will move forward to construction. A sheetpile wall and rock armoring will be used to plug the breach.

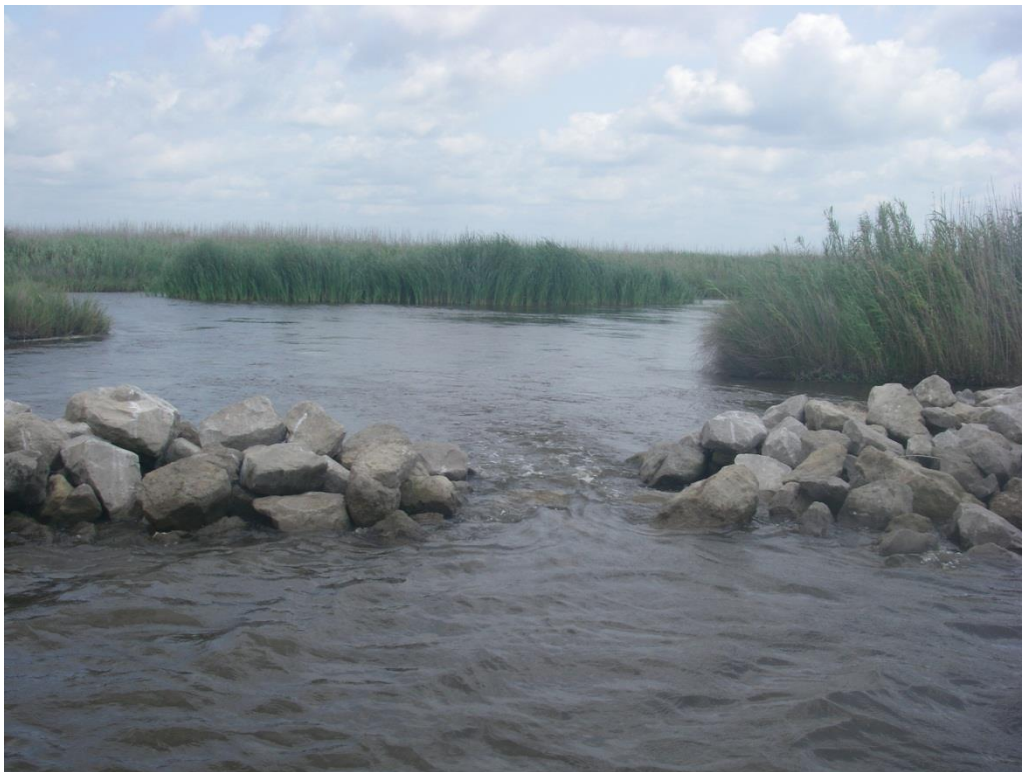
**Photo No. 4,** Water Flow through Displaced Rock Dike, Water Flow Channeling into Marsh
